Strengthening of Single Bay Tunnel Form Building using Steel Angle, Steel Plate and CFRP Under Out-of-Plane Cyclic Loading

Abstract: A one-third scale of 3-storey single unit tunnel form building (TFB) was designed and constructed using non seismic design (BS8110) and tested under out-of-plane lateral cyclic loading. This prototype sample was tested at $\pm 0.01\%$, $\pm 0.1\%$, $\pm 0.25\%$, $\pm 0.5\%$, $\pm 0.75\%$, $\pm 1.00\%$, $\pm 1.25\%$, $\pm 1.5\%$ and $\pm 1.75\%$ drift up to the strength degradation. TFB system is widely used around the world, including seismic prone areas. The seismic performance of this system differs for each country depending on its design, construction quality and the location of the epicenter. Most of the constructed TFB use the old version design code (prior 1970) of practice without seismic compatibility experience severe damage and collapse. Thus, seismic repair and strengthening become an alternative method to enhance the seismic capacity of existing structures. The experimental work to retrofit a 3-storey TFB using a combination of steel angle, steel plate and carbon fiber reinforce polymer (CFRP) fabric was conducted. The lateral strength,

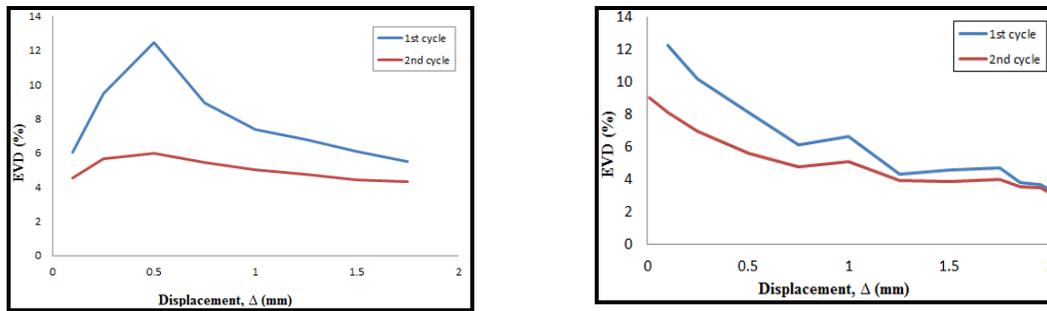
(a) Before retrofitting

(b) After retrofitting

Fig. 4: Equivalent viscous damping (EVD) of the first and second cycles acquired before and after strengthening.

The comparison of the percentage of equivalent viscous damping (EVD) before and after retrofitting is shown in Fig. 4. Energy absorption of TFB during the first cycle of testing started at the minimum value, but increased and exceeded 12% for the first cycle compared to the second cycle. Meanwhile, after retrofitting, TFB seemed to absorb higher energy for both cycles compared to before rehabilitation. However, it observed that the EVD decreased as the drift increased. This indicates that these repair techniques provides a significant increment of EVD percentage during the early stage of the second time testing especially in the first cycle. The materials used did not absorb more energy compared to before retrofitting. Therefore, an additional shear wall with new BRC wire mesh should be used in order to increase the energy absorption of tunnel form building.
